# System Tests and Qualification of Pixel Modules and DC-DC Converters for the Phase-1 Upgrade of the CMS Pixel Detector

Von der Fakultät für Mathematik, Informatik und Naturwissenschaften  
der RWTH Aachen University zur Erlangung des akademischen Grades  
eines Doktors der Naturwissenschaften genehmigte Dissertation

M.Sc. Martin Lipinski

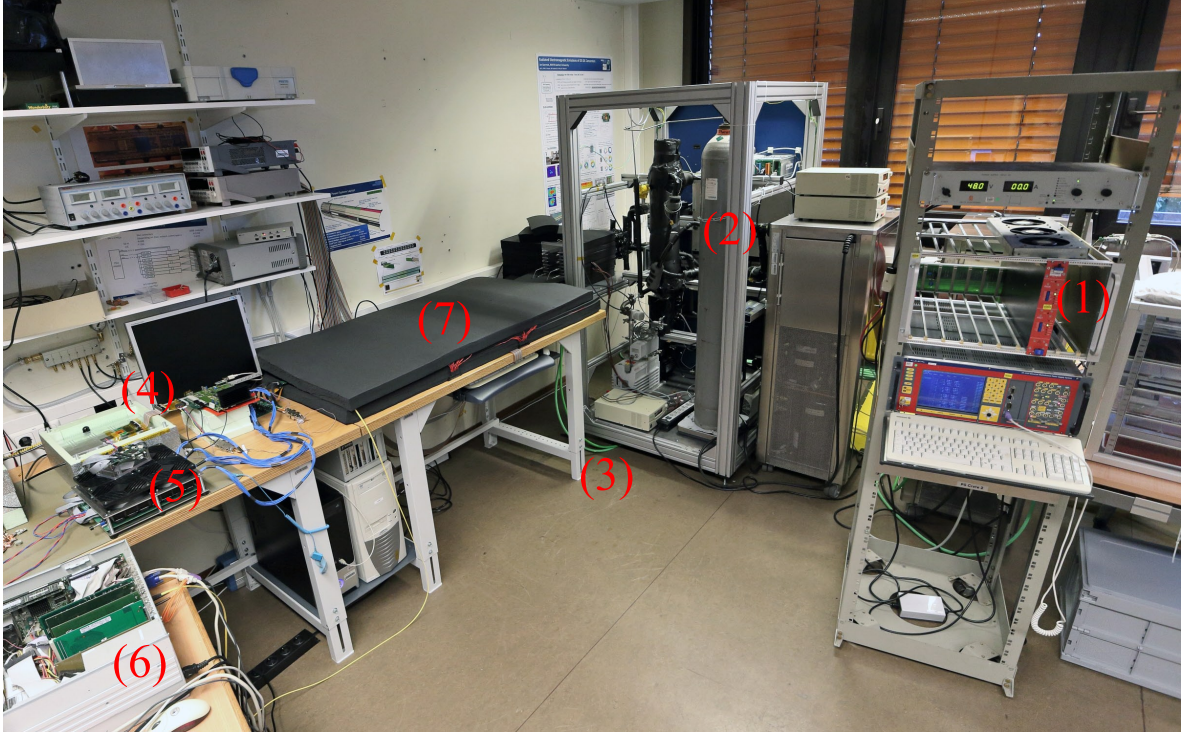
Figure 4.1.: Photograph of the system test setup. It shows the CAEN 4603D power supply (1), the CO<sub>2</sub> cooling system (2), the multi-service cables (3), the pixel module (4), a load board (5), and the computer with the FEC (6). The supply tube boards are covered by insulating foam (7), hence they are not visible.

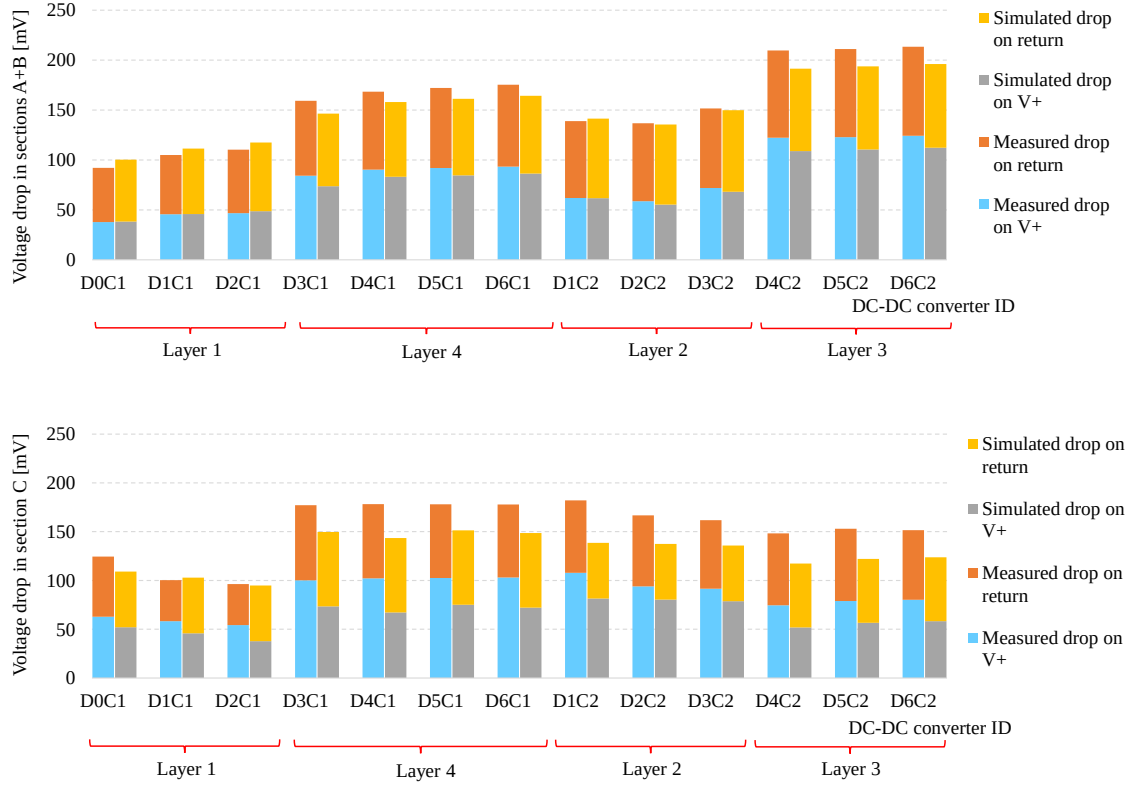
Figure 4.5.: Measured and calculated voltage drops across the supply tube, shown for all digital DC-DC converters of one supply tube slot. Top: voltage drops in sections A and B. Bottom: voltage drops in section C.
